UNDERWATER REFURBISHMENT OF EMBEDDED PARTS ON A BOTTOM GATE – CASE OF BARRAGE DU MIODET

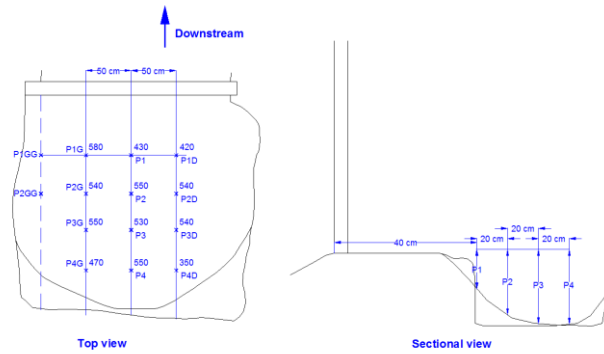
Step 3 : A prior cleaning by high pressure jetting was necessary in order to assess properly extension of erosion and corrosion on embedded parts. Inspection of all components was then implemented by divers equipped with video cameras linked to surface monitors. Thickness measurements of residual steel beams were made by divers and a complete assessment of necessary remedial work was undertaken. Sill beam was completely destroyed and lateral guides were partially missing plus a cavity has formed on the concrete sill upstream of the gate. Decision was taken to remove all embedded parts and to fix a new frame structure pre-fabricated and pre-assembled in a workshop.

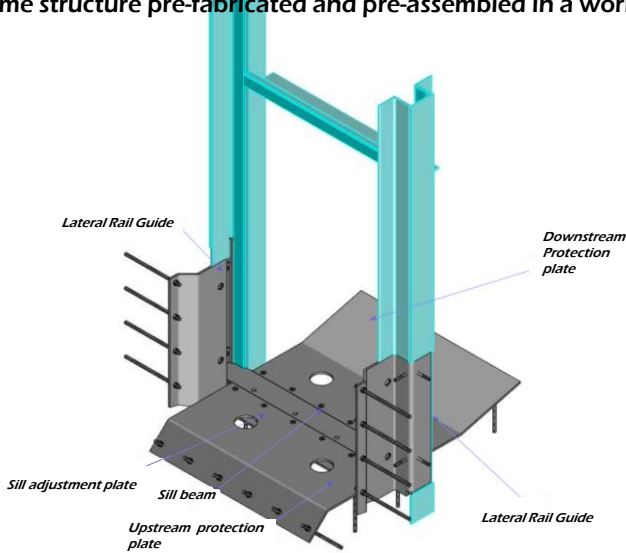
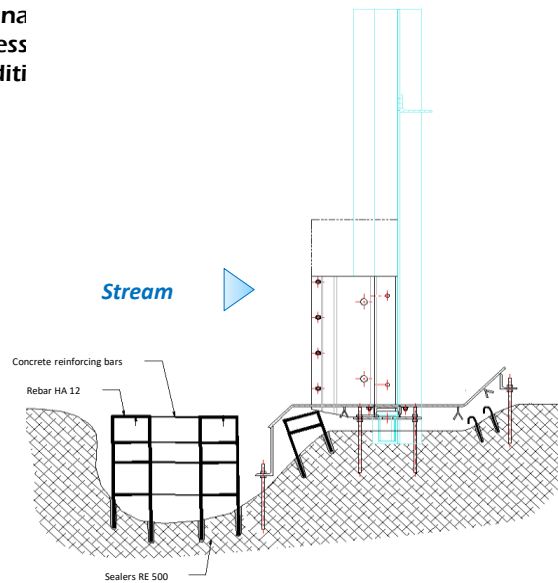
Step 4 : Demolition of embedded parts, second stage concrete, residual steel beams and plates was done using a combina high press and additi

Step 5 : Positioning and adjustment of the frame structure was a challenging task, especially for sill beam and plates which has to be adjusted and fixed in a very precise position before concreting phase. Due to limitation of lifting capacity, sill beam and lateral rail guides were not lifted down in one piece and adjustment underwater was a time consuming phase.

Once adjusted, wet welding of lateral rail guides, sill beam and frontal plate was done. A special welding procedure qualification was designed for this contract according to the ISO 15618 - 1

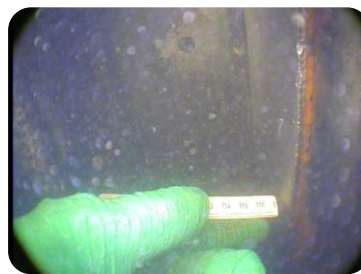
Diver checking
