UNDERWATER REFURBISHMENT OF EMBEDDED PARTS ON A BOTTOM GATE – CASE OF BARRAGE DU MIODET

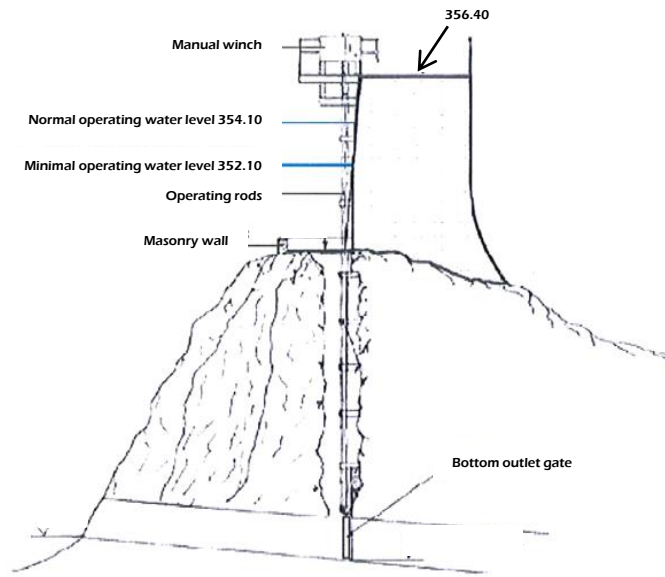
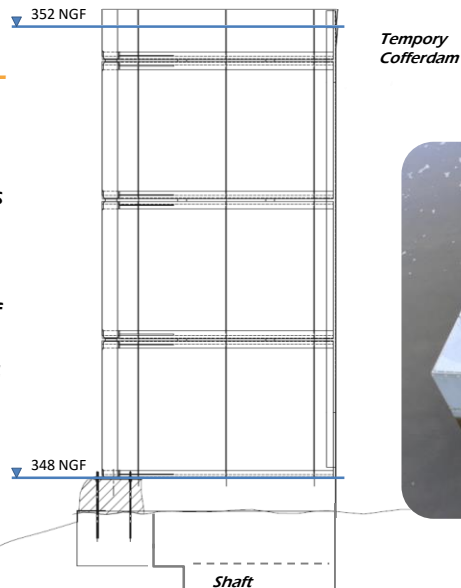
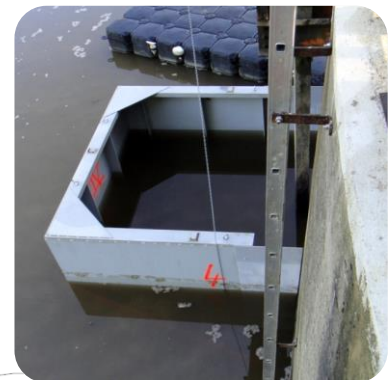
Step 3 : A prior cleaning by high pressure jetting was necessary in order to assess properly extension of erosion and corrosion on embedded parts. Inspection of all components was then implemented by divers equipped with video cameras linked to surface monitors. Thickness measurements of residual steel beams were made by divers and a complete assessment of necessary remedial work was undertaken. Sill beam was completely destroyed and lateral guides were partially missing plus a cavity has formed on the concrete sill upstream of the gate. Decision was taken to remove all embedded parts and to fix a new frame structure pre-fabricated and pre-assembled in a workshop.
